GEOMORPHIC EFFECTS OF URBANIZATION IN FORTY-ONE YEARS OF OBSERVATION

LUNA B. LEOPOLD, REED HUPPMAN, AND ANDREW MILLER

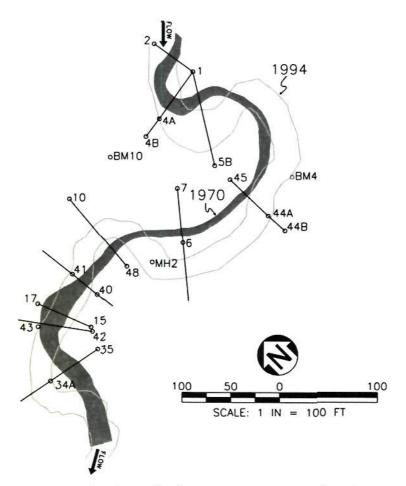
FIGURE 1. Map of study reach of Watts Branch showing channel positions in 1972 and 1994, with locations of iron pins marking the end points of cross sections

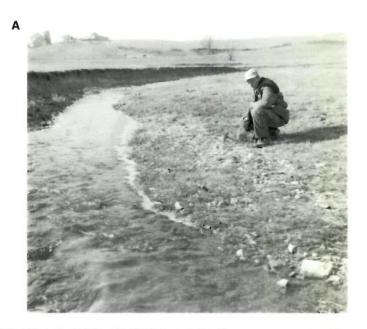
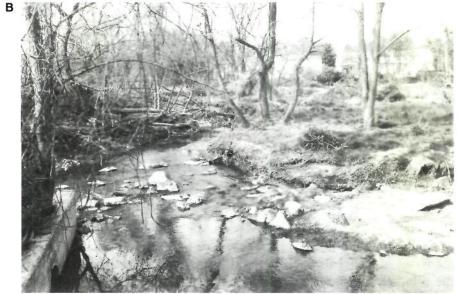
FIGURE 2. View downstream approximately at cross section 53–54. This location is about three hundred feet downstream of the map area of figure 1. Upper photo, figure 2A, taken in December 1959, shows grazed pasture and, in the distance, the original barn. In the lower photo, figure 2B, 1994, housing has replaced the farm. Large rocks in the streambed were introduced from far upstream by flood flows.

The small stream located near Rockville, Maryland, draining 3.7 square miles, was primarily cultivated farmland in 1952, with small areas of second-growth timber. The Piedmont soil is developed on deeply weathered schist. It is red to yellow in color and erodible. In a grazed meadow through which the stream meandered, a series of cross sections was surveyed, the end points of which were monumented. In 1956 a gaging station was installed somewhat upstream of the monumented sections. The general layout of the cross sections is shown in figure 1, and the aspect of the conditions at the start of the study is shown in figure 2A.

The increase in magnitude of the floods changed the bed material in the channel, as seen in figure 2. The many large angular rocks present in 1994 could not have come from bank erosion in the valley fill, because the alluvium is silt-clay and the original bed had inconspicuous riffles made up of fine gravel having a D50 of about 16 mm. Rounded gravel a few feet under the streambed was observed in the sewer trench, but because the bed was aggrading this could not be the source. We believe that the angular blocks of large size were carried into the reach by floods, excavated from the many sites upstream cleared during construction.

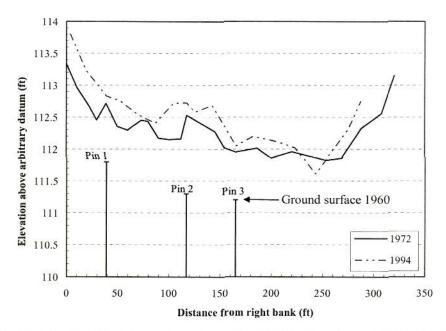
FIGURE 3. Profile of ground surface orthogonal to the channel that records overbank deposition. The three pins were driven down to the ground surface in 1960 on what appeared to the eye as a nearly level flood plain. In 1994, there had been an average deposition of more than a foot in thirty-four years.

After observing the increase in flood flows, we conjectured that overbank deposition, even some distance from the channel, might occur. In April of 1960 three iron pins were driven into the floodplain surface to record its elevation. These were at distances of 40, 128, and 155 feet from the channel. This seemed at the time rather a long shot because massive deposition appeared unlikely. As it turned out, even that small effort paid dividends, because floodplain deposition could not have been judged merely from channel cross sections. Figure 3 shows the profile across the floodplain. Deposition over the whole valley flat was 1.0 to 1.3 feet in depth.

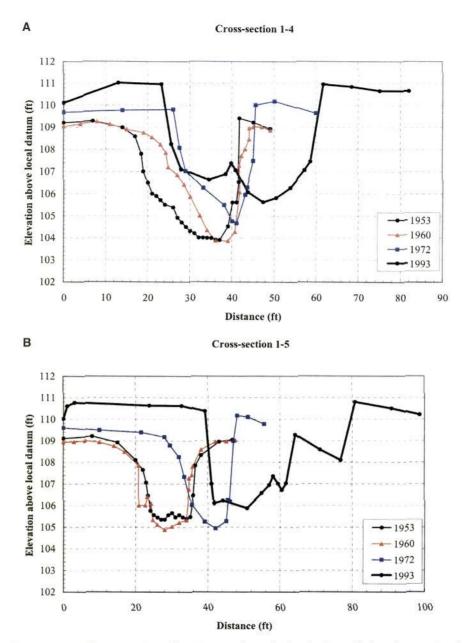
FIGURE 4. Cross sections first surveyed at the beginning of the observational period, 1953, and also in 1993. The aggradation on the streambed and flood plain was accompanied by an increase in width.

Figure 4 includes two of the cross sections originally established in 1953. These plots show no appreciable bed aggradation at or until after 1960, but great widening in the same period.

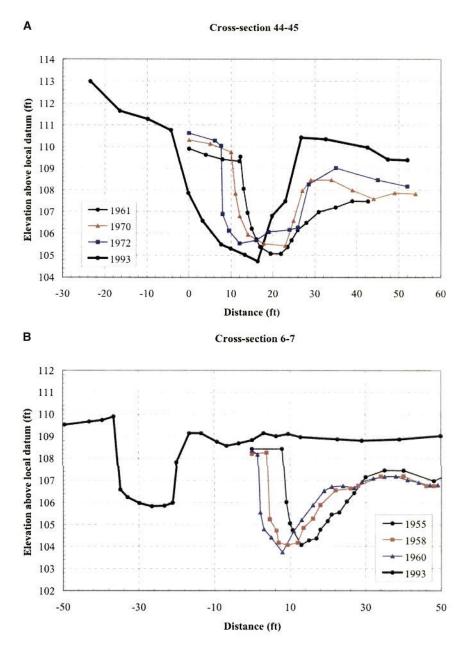
FIGURE 5. Section 44–45 had experienced a large increase in width and overbank deposition, but without bed aggradation. Section 6–7 moved laterally a large distance and aggraded its bed.

Figure 5A shows considerable widening after 1961. Immediately downstream at section 6–7, a great burst of lateral motion and consequent deposition moved the channel laterally and built the bed about two feet vertically. The lateral movement through this reach washed out the iron pin at Station 44; it was replaced at a position farther from the bank.

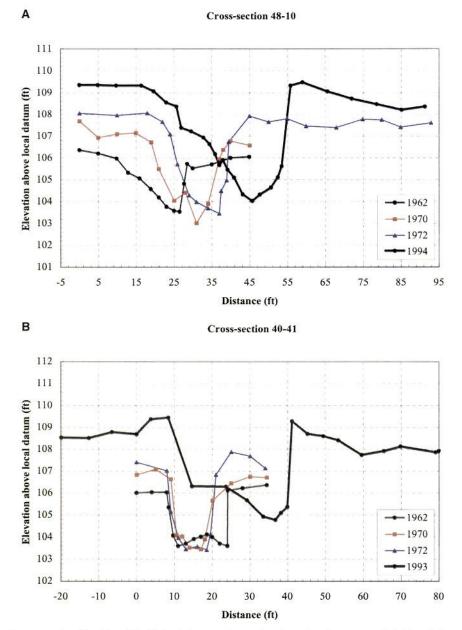
FIGURE 6. Section 48–10 had impressive point bar development with 5 to 6 feet of deposition in thirty-two years. Section 40–41 did not change width in the first ten years, but greatly increased width in the next twenty years.

Figure 6A shows the channel building its bed by deposition after 1970 as well as channel enlargement. At Section 40–41 in figure 6B,

the channel had remained nearly the same size with merely some overbank deposition between 1962 and 1972, but from that year to 1993, the bed increased elevation by nearly 3 feet, and the channel doubled its area. Figures 7A and 7B show bed aggradation after 1970 as well as overbank deposition without much change in area, but massive change after 1972. In figure 8, the channel at Section 34–35 moved progressively from 1958 to 1993, with greatest deposition in the last twenty years of the period.

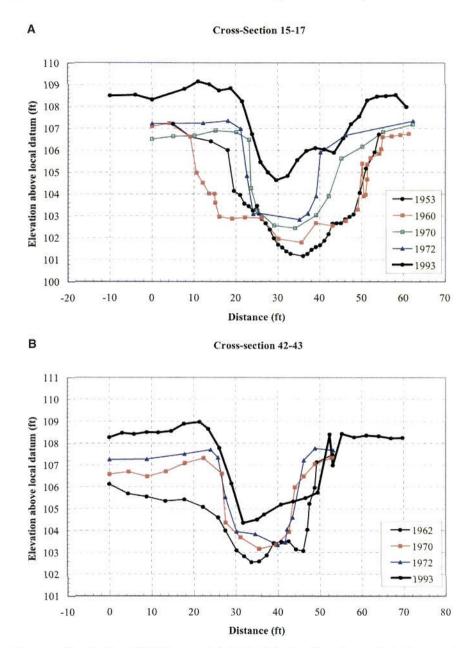
FIGURE 7. Section 15–17 aggraded its bed, but with only modest decrease in channel area. Section 42–43 showed massive deposition on the point bar of the left bank.

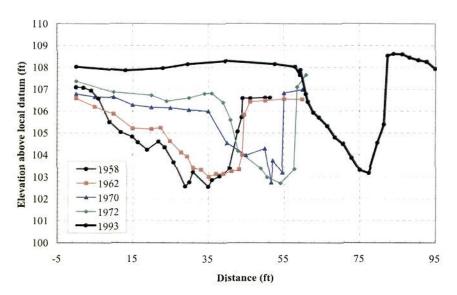
Cross-section 34-35

FIGURE 8. Section 34–35 moved progressively, but the largest deposition on the point bar was after 1972.

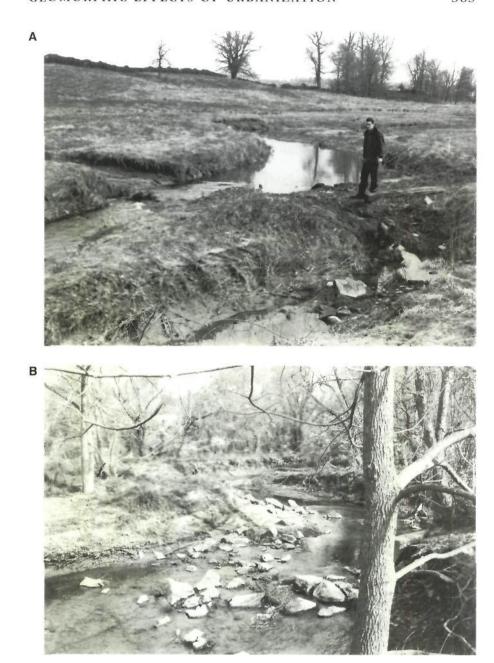
FIGURE 9A. View upstream in 1962 near a small island at Section 42. In 1994, figure 9B shows large angular rocks that had been brought in by floods.

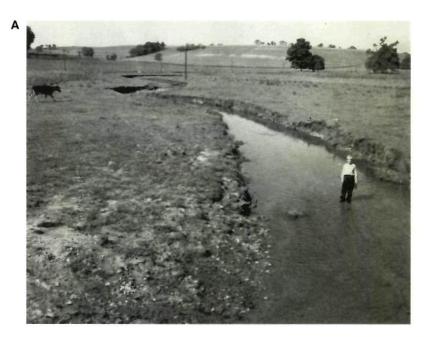
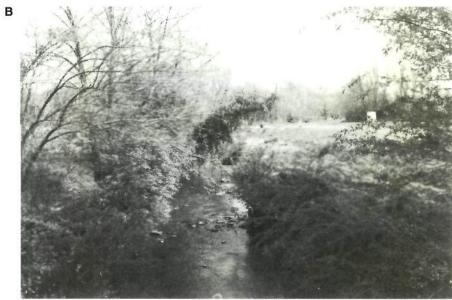
FIGURE 10A. View upstream in 1954 from bridge at lower end of the study area. Figure 10B shows the same view in 1994.

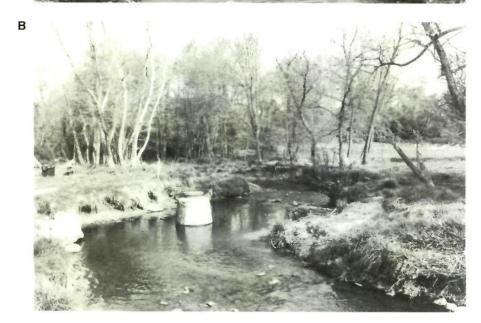
FIGURE 11A. View downstream in 1961 showing manhole far to the left of the channel. By 1994, in figure 11B, the channel had moved so far that the manhole stood in the center of the stream.

In 1961 a sanitary sewer line was put in a trench that extended downvalley through the study area. Though several meander bends were destroyed and some cross sections lost, the long-term effect was beneficial. The open trench provided an opportunity to study the stratigraphy of the valley fill, and the manhole covers gave us two permanent benchmarks.

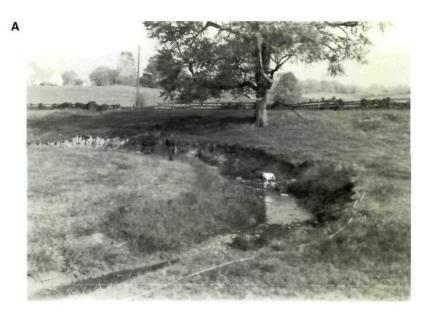
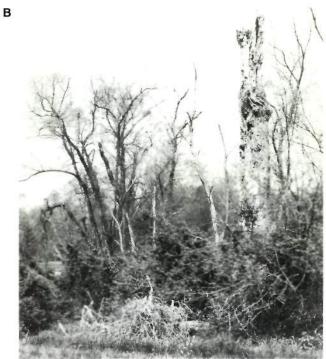
FIGURE 12A. View upstream in 1954 toward the maple tree on the roots of which we had put one of the principal benchmarks, BM 4. In figure 12B, photographed in 1994, the maple tree, now dead, has its roots eroded away by lateral movement of the stream. The channel is hidden in the brush at the bottom of the photo.
